Eductor Retardant Mixer Phosbins – Blockage Issues

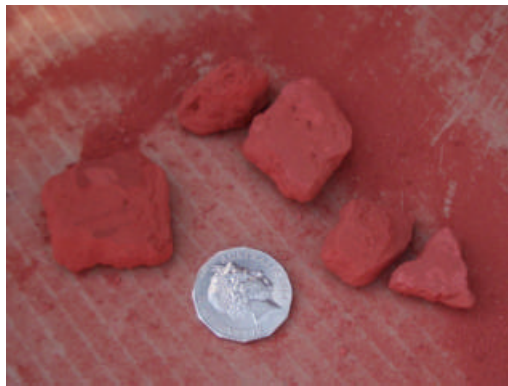
In the course of the current fire season, problems have arisen with blockages in the powder flow from the phosbins to the eductor. Further investigation has found lumps of hardened powder in the phosbins that have originated from contamination at the production plant in California, USA. These lumps, or 'phosrocks', are distinct from compressed powder as they have chemically hardened and cannot be crushed in your fingers. The average size of these phosrocks has been around 5cm long, 3cm wide and around 1cm thick. The mechanical action of the eductor is not capable of breaking these lumps and hence blocking occurs.

Not all phosbins have this problem. Investigation is underway to gather details on occurrences, and serial numbers to isolate production runs that have been contaminated. A system of sieving phosbins to strain out any phosrocks has been set up and re-sieving of old stock is underway.
