Airfield Communications Caravan: Altona and Bacchus Marsh

For Information:

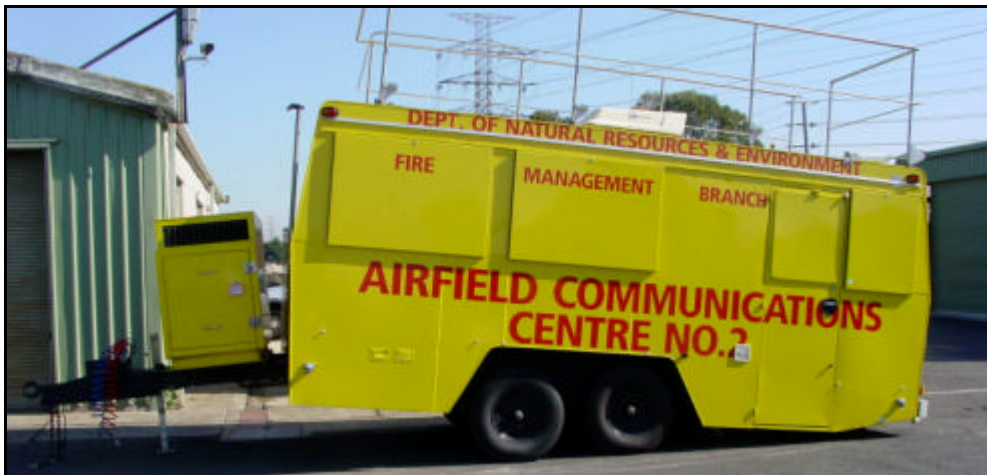
Figure. 1.

A significant structural failure occurred with the Altona based Airfield Communications Caravan after the completion of an equipment upgrade fitting. The communications unit was returning from Geelong after having a roof mounted guardrail fitted to comply with occupational health and safety requirements. The draw bar on the front of the unit collapsed when it entered the driveway at Altona. See Figure 1.

Both of the communications caravans have now been declared **UNSERVICABLE** and not to be used for any agency operations. They have been withdrawn from service and are not to be used for any purpose until further notice.

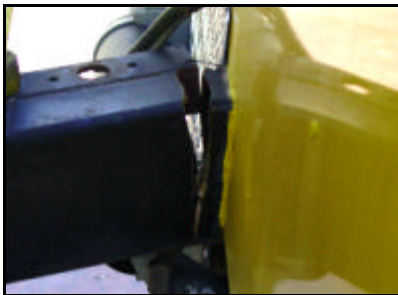
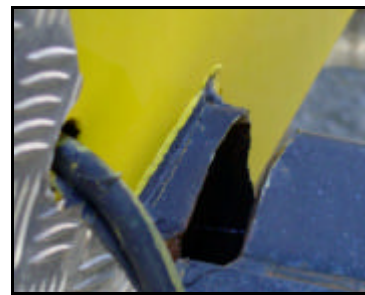
Figure. 2.

The collapse of the draw bar occurred as a result of cracks, which had developed in the draw bar frame at the rear of the power generator near the cabin. See Figure 2 & 3. It has been determined that the cracks had developed over a period of time and have not been attributed to any single event. A subsequent check was conducted on the Bacchus Marsh communications caravan, which was also being refitted with the same roof-mounted guardrail. Fatigue cracks were also found on the Bacchus Marsh unit in the same place.
